Marine Investigation Preliminary Report

Contact of Containership *Dali* with the Francis Scott Key Bridge and Subsequent Bridge Collapse

Location:	Baltimore, Maryland	Accident Number:	DCA24MM031
Date and Time:	March 26, 2024 0129 local time (eastern daylight time)	IMO Number:	9697428
Ship:	<i>Dali</i> (Neo-Panamax containership)	Injuries:	8 (6 fatal)

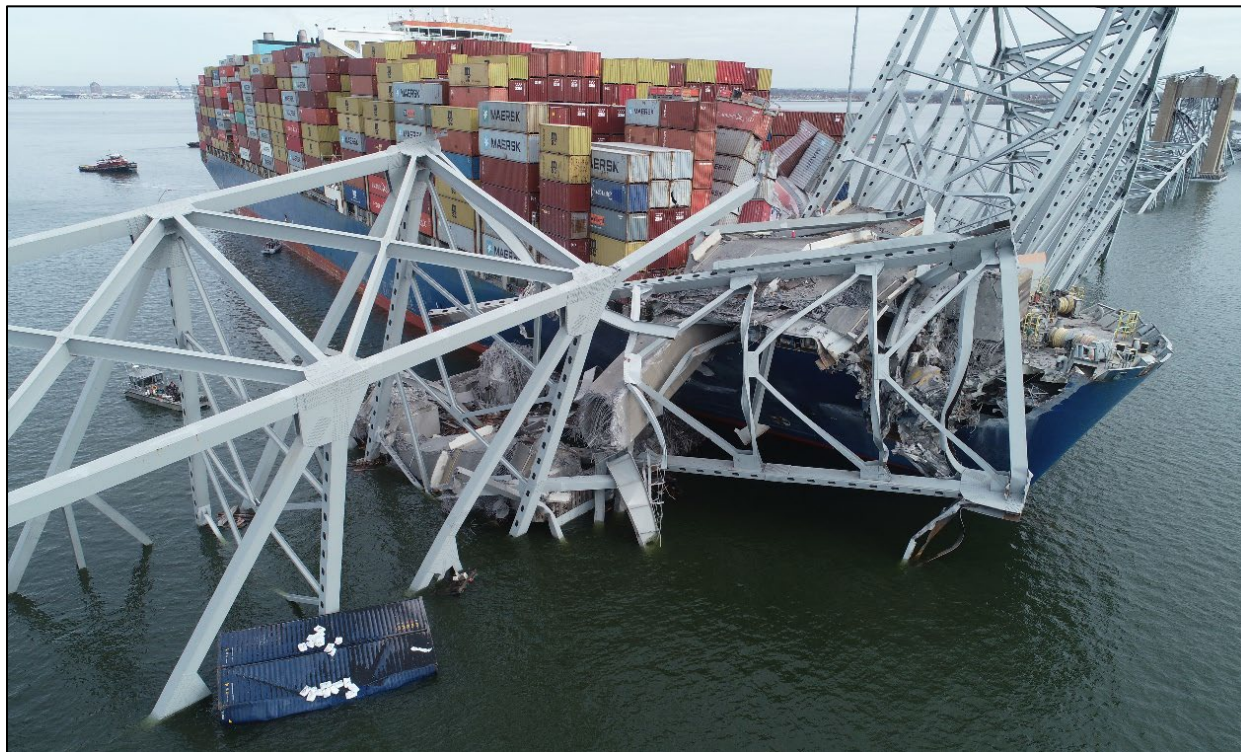
Figure 1. The *Dali*, with portions of the collapsed Key Bridge across its forward deck and in the Patapsco River, on March 28.

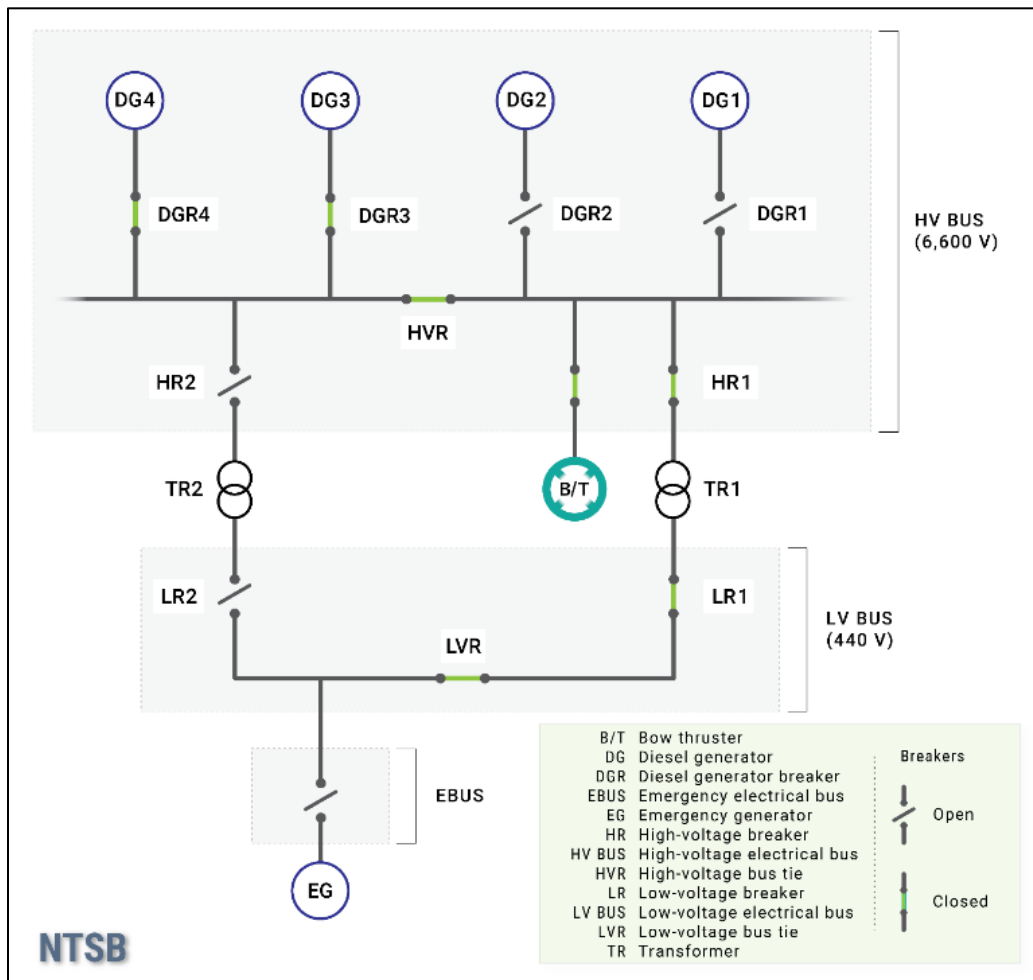
Figure 5. Simplified one-line electrical diagram of the *Dali* electrical power distribution system. Breakers shown reflect their positions at departure on March 26.

About 0125, the *Dali* was 0.6 miles—or three ship lengths—from the Key Bridge when electrical breakers (HR1 and LR1) that fed most of the vessel's equipment and lighting unexpectedly opened (tripped) (see figure 7). This caused the first blackout (loss of electrical power) to all shipboard lighting and most equipment, including the main engine cooling water pumps (which controlled engine cooling water pressure) and steering gear pumps.

- The *Dali* crew was able to restore electrical power to the vessel, but, when the ship was 0.2 miles from the bridge, a second electrical blackout occurred because DGR3 and DGR4, the breakers that connected generator nos. 3 and 4 to the HV bus, opened, causing a total loss of vessel electrical power (HV bus and LV bus). Having connected to the emergency bus by this time, the emergency generator provided electrical power to the emergency equipment continuously through the second electrical blackout.
- Generator no. 2, which had previously started automatically because it was in standby mode, connected and restored power to the HV bus via DGR2.

The first vessel blackout after departure on March 26 occurred when the HR1 and LR1 breakers opened unexpectedly.

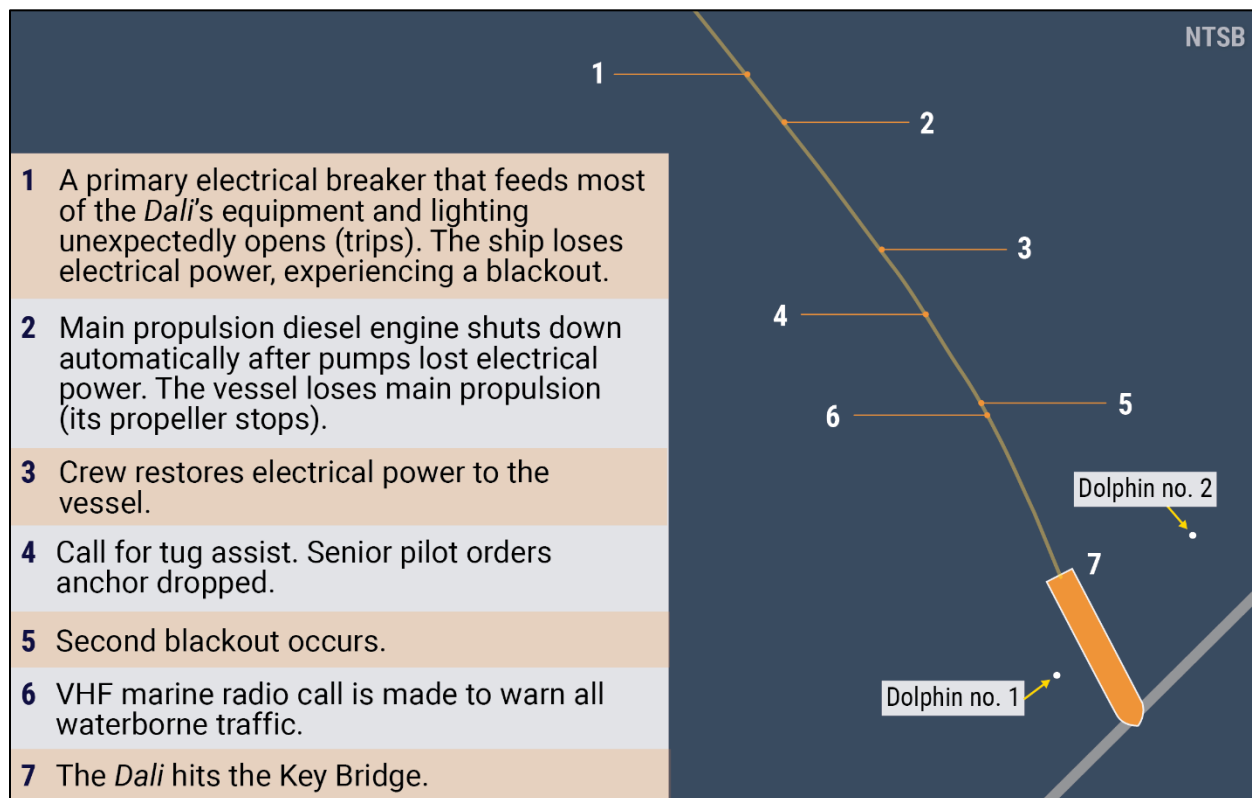
Figure 7. The *Dali*'s route on March 26, between the first blackout, and the *Dali* striking pier no. 17 of the Key Bridge. The location and approximate size of two of the bridge's "dolphins," sheet pile and concrete structures protecting the bridge's piers, are labeled in the lower right.

At 0129:10, the *Dali's* starboard bow struck pier no. 17 of the Key Bridge at 6.5 knots. Six spans of the bridge (the main spans [17, 18, and 19] and spans 20, 21, and 22) subsequently collapsed into the water and across the ship's bow. A *Dali* crewmember, who was on the bow at the time of the accident, told investigators that, as he was releasing the brake on the port anchor, he had to escape from the falling bridge before he was able to reapply the brake. (Due to ongoing salvage efforts, the amount of anchor chain paid out is still unknown.)

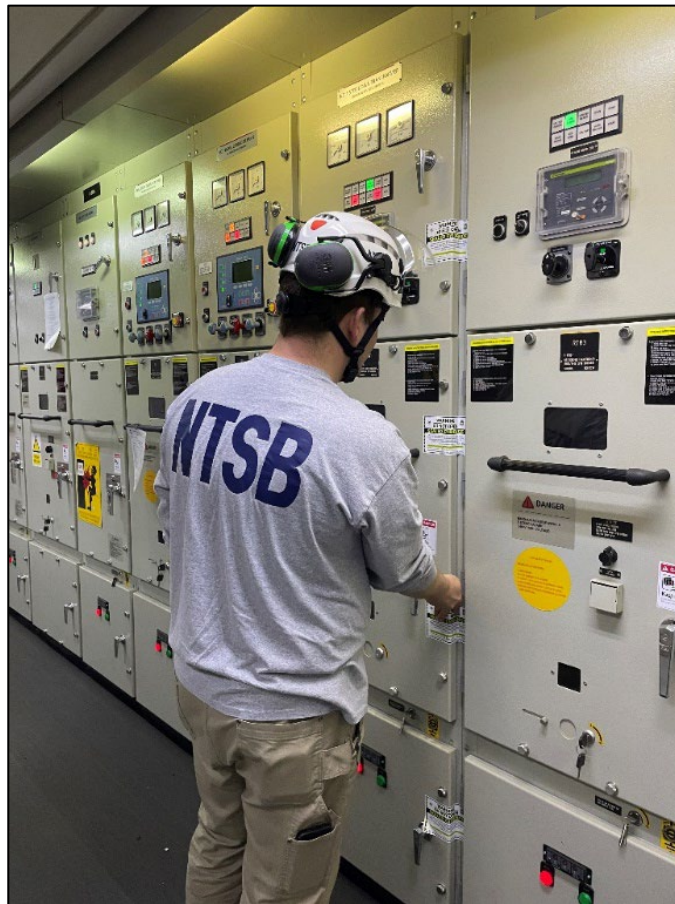
The *Dali* was equipped with an integrated control and monitoring system (ICMS) that retained information related to machinery and system changes and resulting alarms, including vessel engines and the electrical power management system. The NTSB has managed testing of the vessel's HV electrical bus and its components (including the HV and LV breakers) as the investigation parties and the electrical bus manufacturer, HD Hyundai Heavy Industries, Co. Ltd., work to identify the cause(s) of the breakers unexpectedly opening while approaching the Key Bridge and the subsequent blackouts (see figure 8).

Figure 8. An NTSB investigator examining the *Dali*'s HV switchboard (which houses the HV bus) and applying tamper-evident preservation seals.

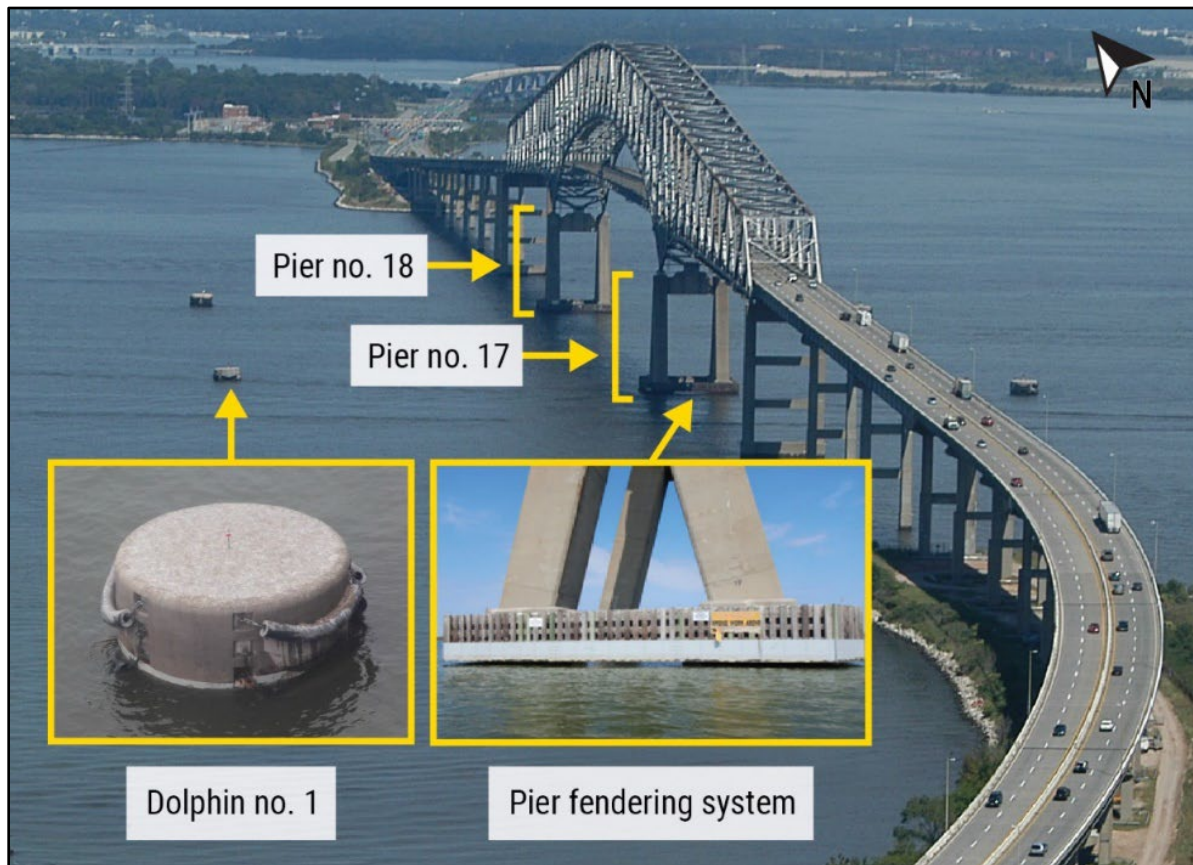
Figure 12. The Key Bridge and the locations of pier nos. 17 and 18. Insets show dolphin no. 1 as well as pier no. 17's fendering-system surrounding. (Background source: MDTA)

In addition to the dolphins, pier nos. 17 and 18 were each surrounded by a 100-foot-by-84.5-foot crushable concrete box and timber fender system, as seen in figure 12. These systems were comprised of hollow, thin-walled, concrete box structures attached to the piers. The timber portions of the fender were attached to the outer face of the concrete box and utilized a combination of vertical and horizontal members. Additionally, steel plates were secured at the base of the vertical timber members.

The *Dali* struck pier no. 17 and the fendering system surrounding the pier but did not contact dolphin no. 1 or its rubber fenders. Both fendering systems surrounding pier nos. 17 and 18 were further damaged during the collapse of the truss spans of the bridge when components of the truss spans impacted portions of the fenders as the components fell into the water.
