Marine Investigation Preliminary Report

Contact of Containership *Dali* with the Francis Scott Key Bridge and Subsequent Bridge Collapse

Location:	Baltimore, Maryland	Accident Number:	DCA24MM031
Date and Time:	March 26, 2024 0129 local time (eastern daylight time)	IMO Number:	9697428
Ship:	<i>Dali</i> (Neo-Panamax containership)	Injuries:	8 (6 fatal)

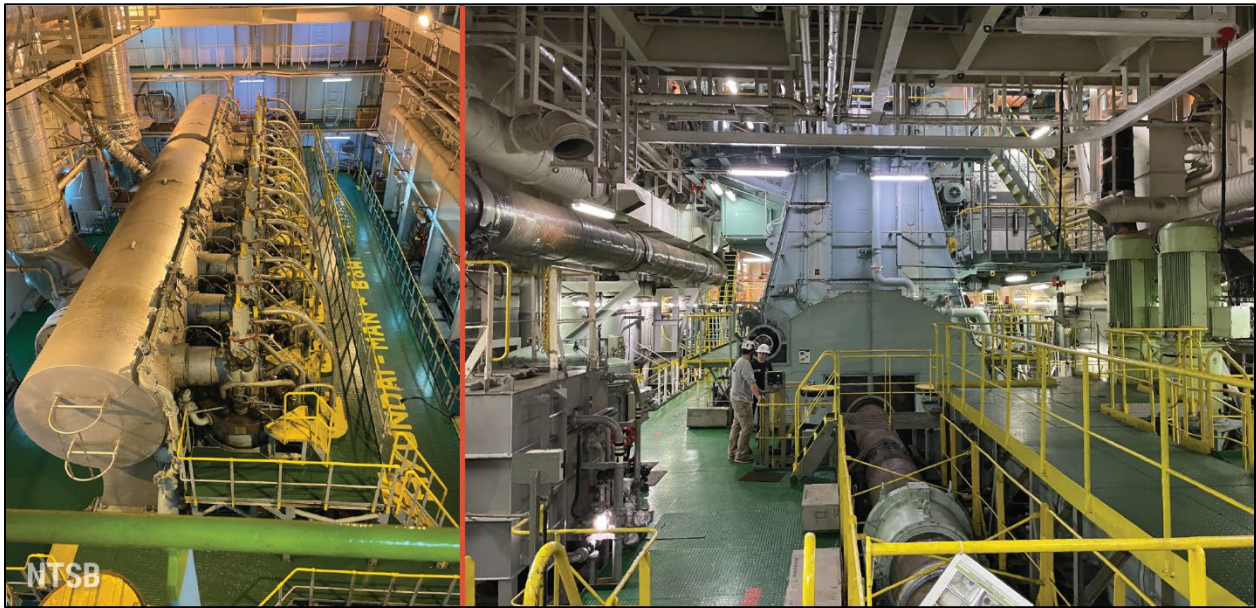
Figure 2. Left: The *Dali*'s main engine room (looking aft), showing the vessel's engine. Right: NTSB investigators examining the lower level of the vessel's engine room (looking forward).

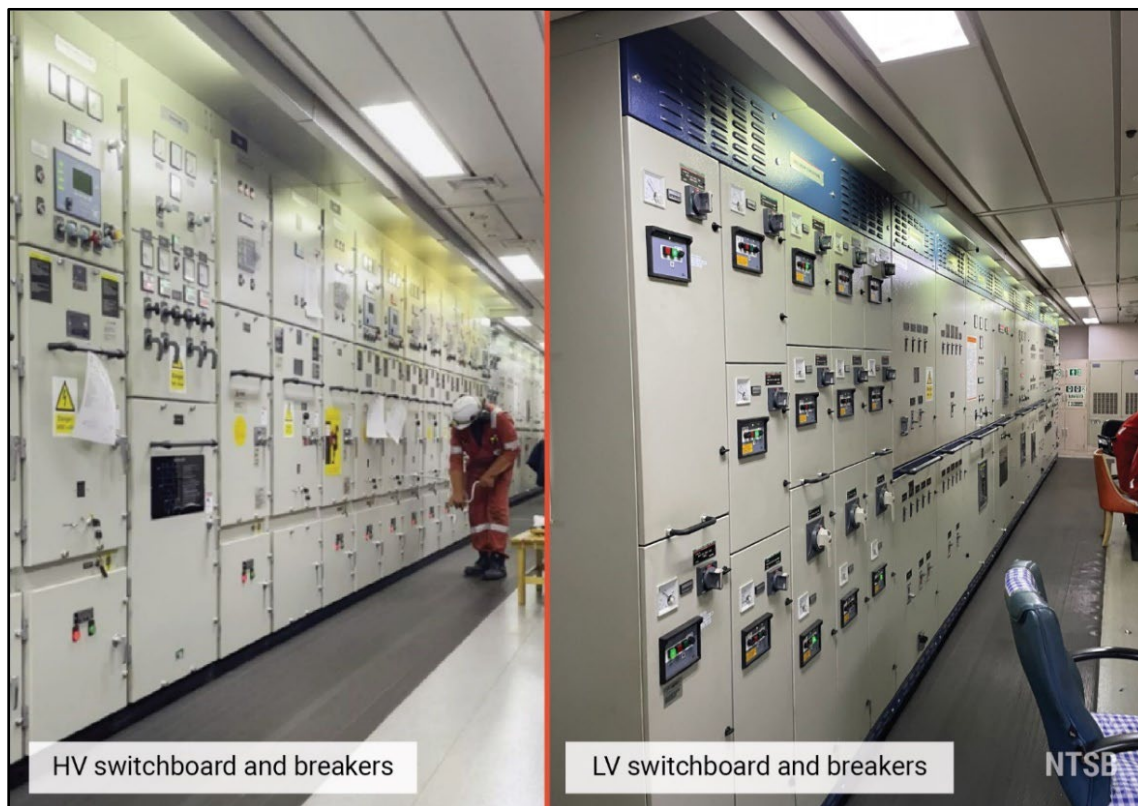
Figure 3. The *Dali*'s power management system in the ship's engine control room. The HV switchboard (which houses the HV bus) and breakers (*left*) and the LV switchboard (which houses the LV bus) and breakers (*right*).

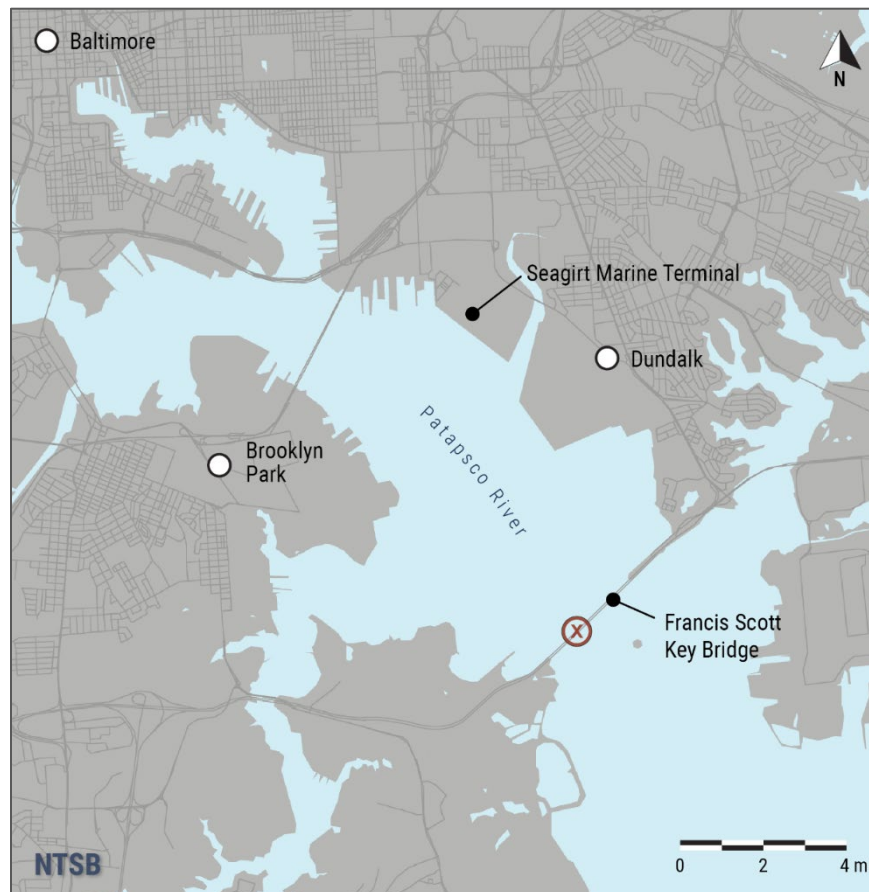
Figure 4. Area where the *Dali* struck the Key Bridge, as indicated by the red X. (Background source: Google Maps)

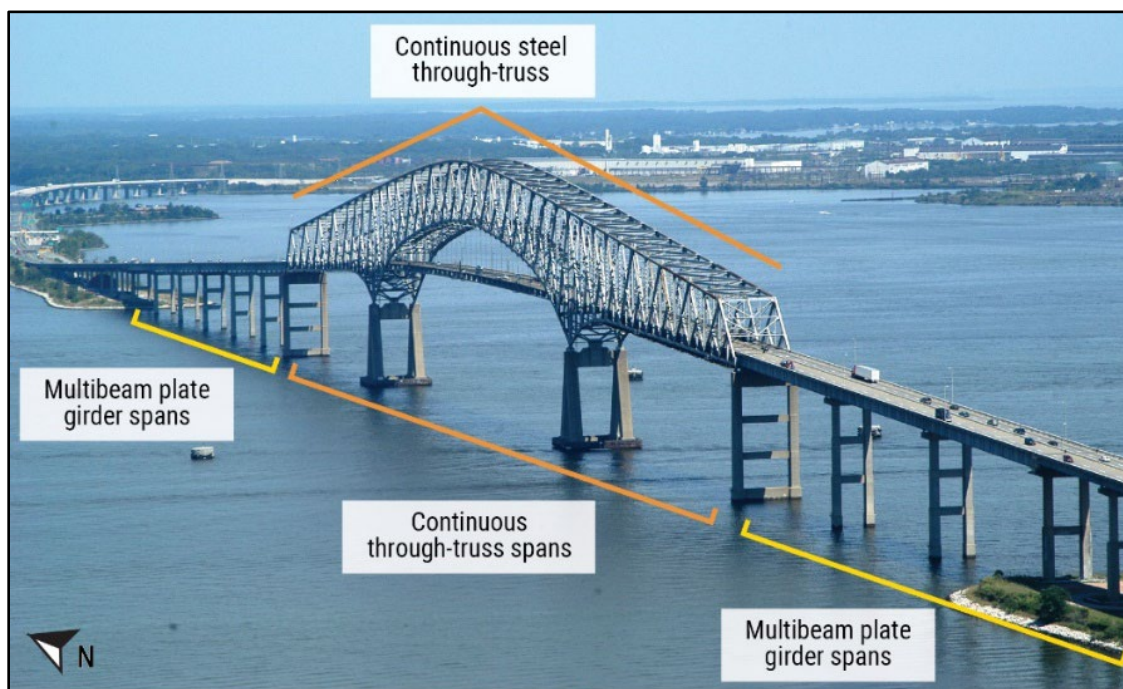
Figure 10. The Key Bridge with its truss and spans labeled. (Background source: MDTA)

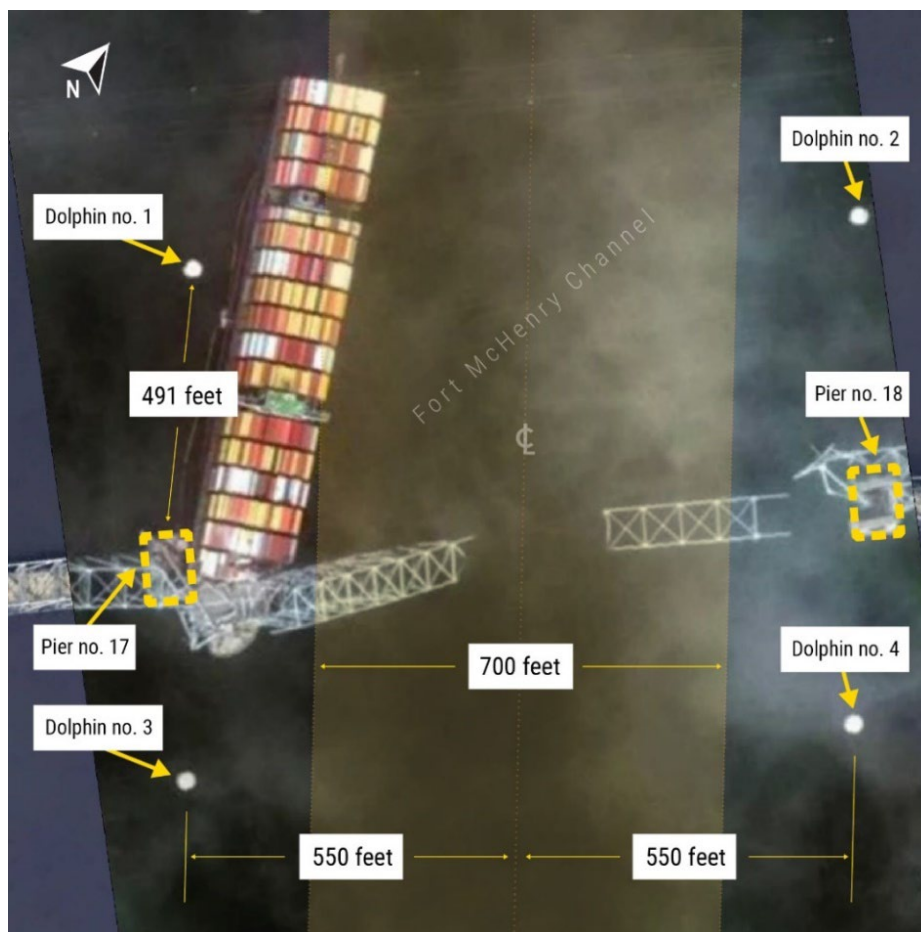
Figure 11. Locations of dolphins relative to the *Dali*, the Key Bridge, and Fort McHenry Channel. (Background sources: MAXAR and Google Earth)
