MLA Inland Waters & Towing Committee Meeting

Cell Phone Use, Liability, and Cell Phone Policies for Marine Operators

Collision Between U.S. Coast Guard Vessel CG 33118 and
Sea Ray Recreational Vessel CF 2607 PZ
San Diego Bay, California
December 20, 2009

Collision of Tugboat/Barge *Caribbean Sea/The Resource*
with Amphibious Passenger Vehicle *DUKW 34*
Philadelphia, Pennsylvania
July 7, 2010

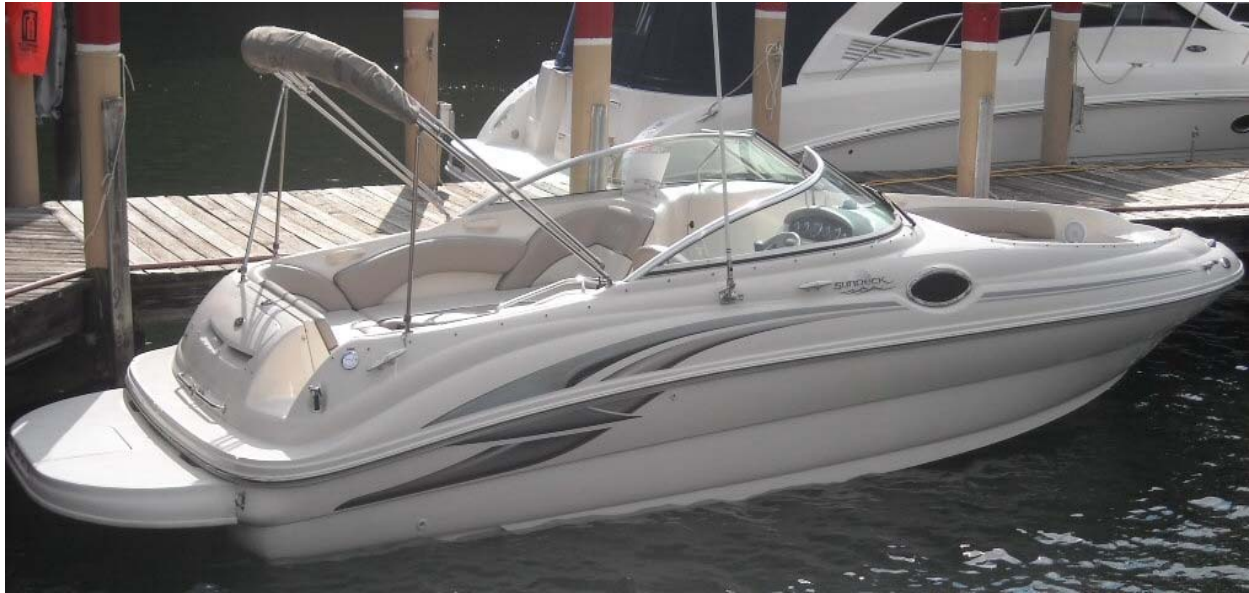
Figure 2. A 24-foot-long Sea Ray recreational boat similar to the one involved in the accident. Photo by Sea Ray, Inc.

About 1715, the 24-foot-long Sea Ray recreational boat (**figure 2**) left its berth at the Harbor West Marina located at the west end of Harbor Island. On board were three families: the operator, his wife, and three children; and two other couples with two children each. In total, 13 people were on board. After departing the marina, the Sea Ray operator proceeded along Harbor

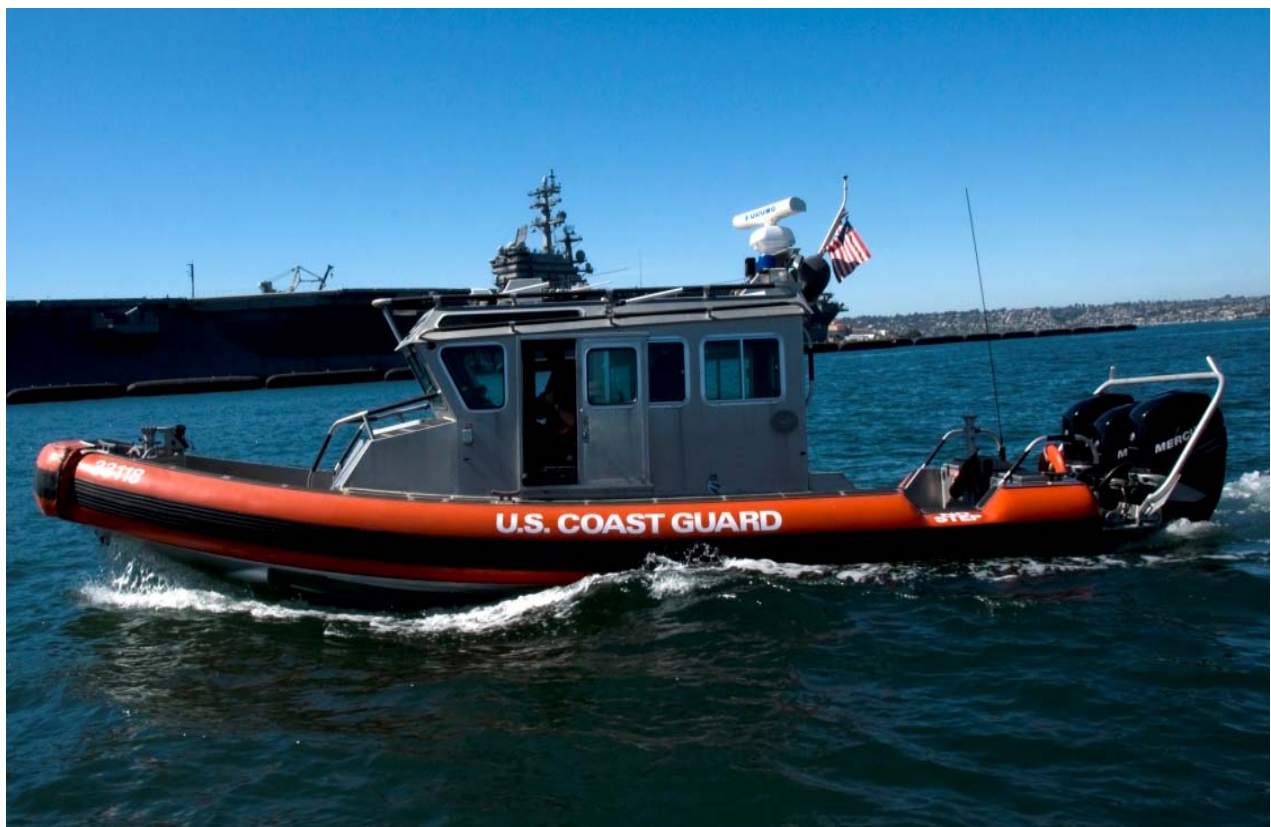
Figure 3. SPC-LE CG 33118. Photo by the Coast Guard.

The *CG 33118* (**figure 3**), which the Coast Guard designates a "special purpose craft – law enforcement" or SPC-LE, and its crew were not assigned to the Parade of Lights. The IAP for the event stated that the patrol commander could call on a station asset (such as the *CG 33118*) to support law enforcement activity; however, one was not requested.

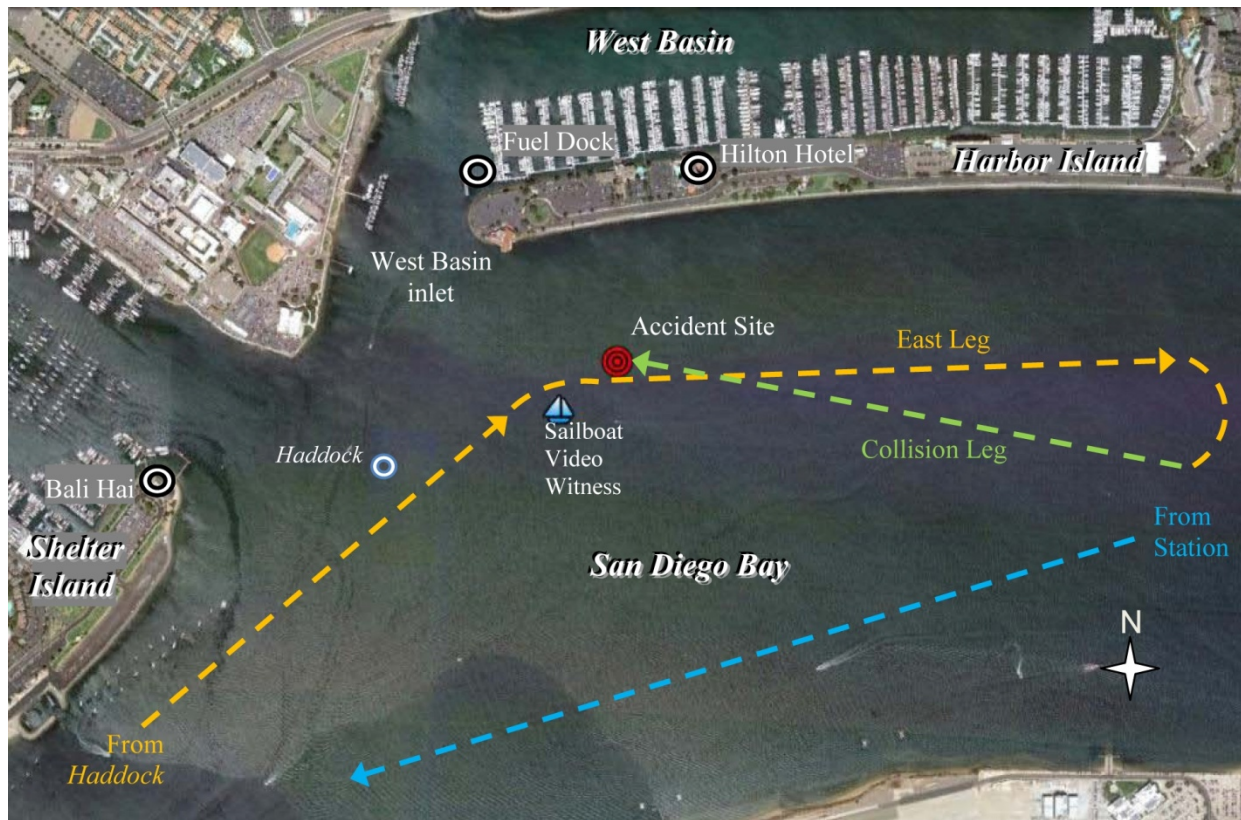
Figure 4. The path of the CG 33118 from Station San Diego to the *Haddock*, then northeast and east across the bay, and then returning west to the accident site. Also indicated are the locations of the Coast Guard cutter *Haddock* at the time of the accident, the sailboat from which a witness filmed a video that the NTSB later used for video and sound analysis, and the Hilton Hotel from which witness photographs were taken of the accident scene.

At 1723, the *CG 33118* crew notified the JHOC of its departure from Station San Diego. When the fireworks display began at 1730, the crew stopped the vessel to watch. When the display ended about 5 minutes later, the *CG 33118* proceeded toward Shelter Island on the west side of the bay where the boat parade was to start. When the *CG 33118* reached that location, the crewmembers radioed the *Haddock's* crew, stating that they had no specific assignment related to the parade but would be nearby and could provide assistance if requested. **Figure 4** shows the approximate route of the *CG 33118* across San Diego Bay.

Figure 4 in section 1.2.2, Accident Narrative, *CG 33118*, depicts the approximate path that the *CG 33118* took leading up to the accident.

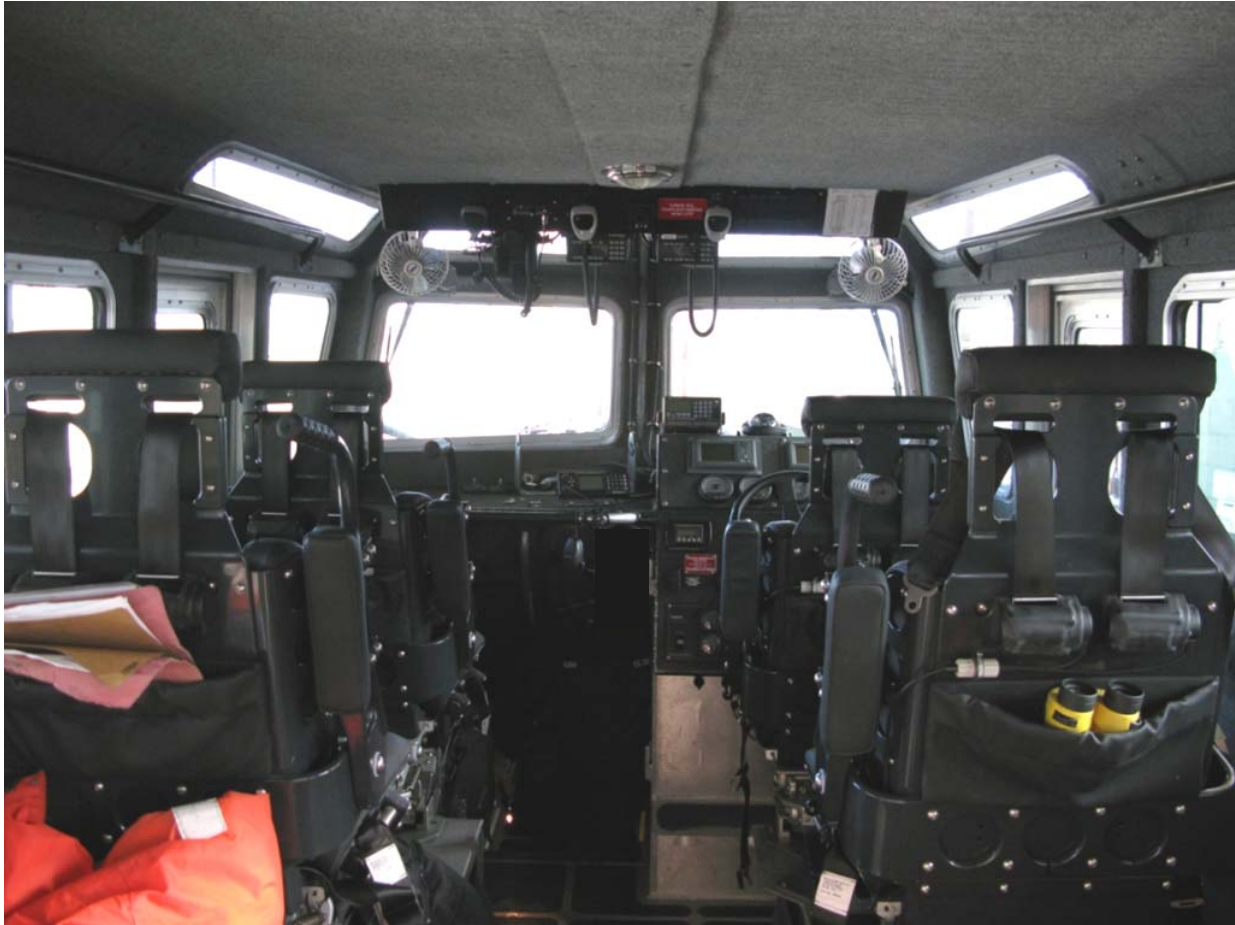
Figure 5. Interior of the CG 33118 cabin.

SPC-LEs are equipped with a scalable integrated navigation system (SINS) built around a radar chart plotter. The SINS includes a radar antenna,²⁸ a 10.4-inch color LCD surface radar-chart plotter display (with range scales from 0.125 to 24 nautical miles), a differential global positioning system²⁹ (DGPS) receiver and navigator display, a multidisplay repeater, a heading sensor, and a depth sensor. The vessel's communication system consists of a loudhailer,³⁰ an ultrahigh frequency³¹ (UHF) marine radio, two VHF-FM marine radios, and a high-frequency-single-sideband³² (HF-SSB) marine radio.

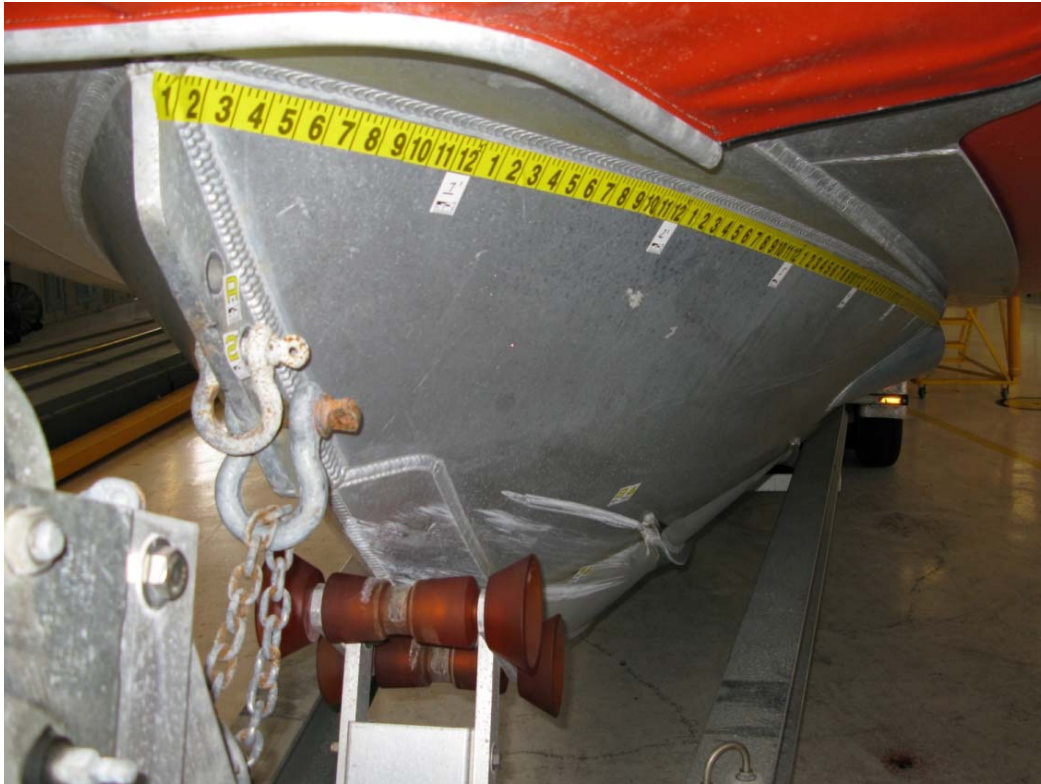
Figure 6. Damage to the CG 33118.

The CG 33118 sustained surface scratches and paint transfer starting at the beaching plate³³ at the stem and continuing aft along the keel for about three-quarters of the length of the hull (**figure 6**). The crewmembers indicated that they did not notice any major postaccident problems with the vessel's performance on the way to impoundment at Coast Guard San Diego's helicopter hanger.

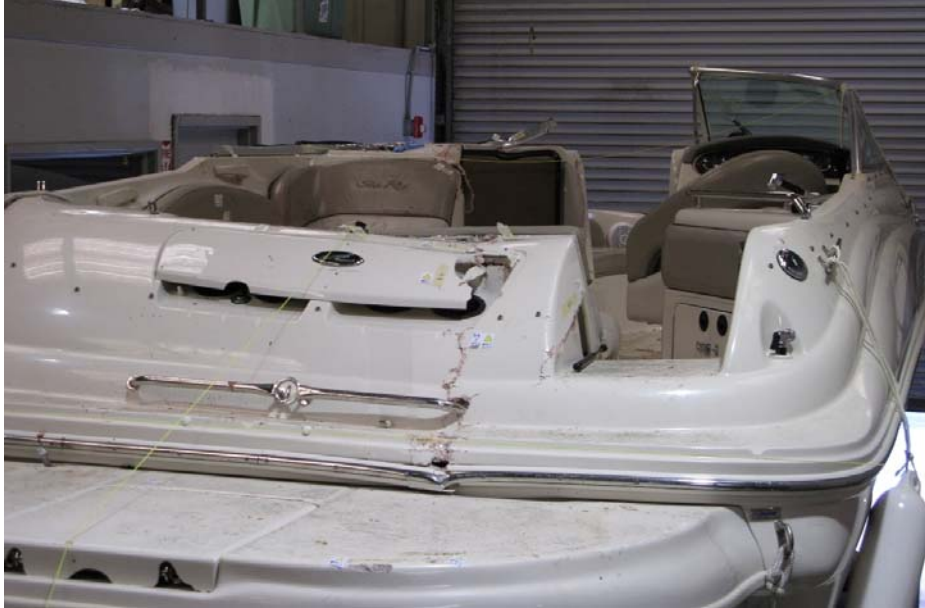
Figure 7. Damage to the Sea Ray.

Most of the Sea Ray's damage was located above its water line, from the starboard side of the transom and extending forward of the port windshield (**figures 7 and 8**). The port window was torn off and the remaining frame bent outward. The fiberglass at the sheer below the missing port window had failed and cracked down the length of the remaining window frame. The door to the head,³⁴ located just below the port window, was knocked off and pushed inward. The swim platform in the stern had a sharp gouge on the starboard side. The structural fiberglass damage to the Sea Ray rendered the vessel beyond repair.

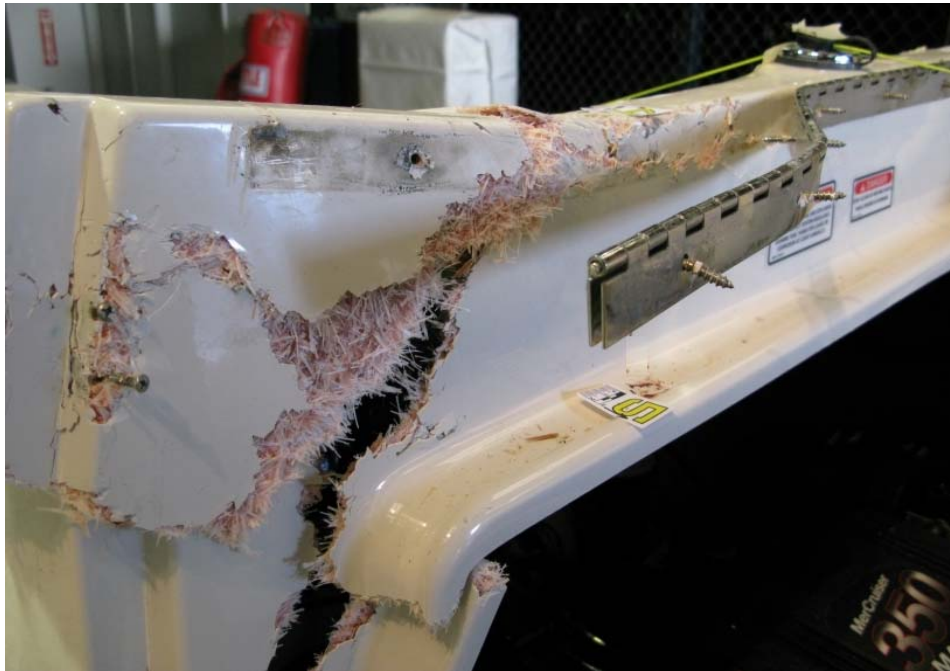
Figure 8. Fractured fiberglass on the Sea Ray, viewed looking aft and port from inside the boat's cockpit.

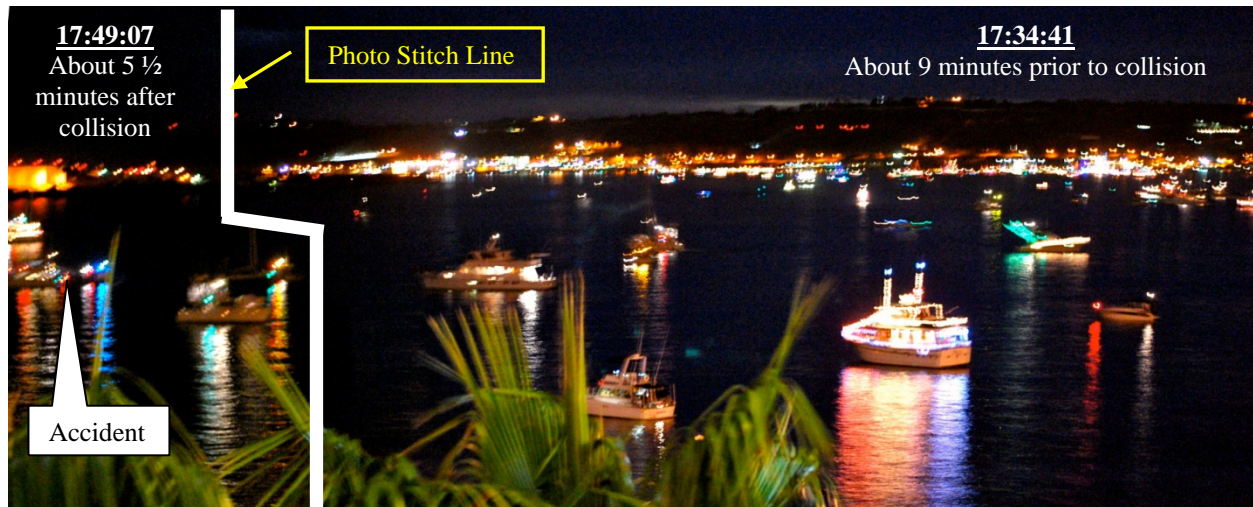
Figure 10. View of San Diego Bay looking southwest from the sixth floor of the Hilton Hotel near the western end of Harbor Island before and after the collision. The two combined photos illustrate the waterway traffic before the accident (right) and the location of the accident site (left). The CG 33118's approximate path to the West Basin would have been from the left to the right through the combined photos. (These two photos were the best available, and were taken as close as possible to the time of the accident.) Photo courtesy of T. Beckman.

Vessel density in San Diego Bay was considered heavy at the time of the accident. SDHP officers stated that on the night of December 20, 2009, the bay was congested with hundreds of boaters because of the Parade of Lights. One officer characterized the Parade of Lights as bringing “one of the highest amounts of boat traffic on any given date in San Diego Bay.” In its accident report, SDHP noted that its vessel therefore responded to the collision “at a slow rate of speed due to the very heavy vessel traffic.” Witnesses also characterized heavy traffic density from the north end of Shelter Island to the Hilton Hotel on Harbor Island, along the parade route. As noted earlier, the Sea Ray operator estimated that about 20 vessels were within 50 yards of his boat at the time of the accident. Many spectator vessels were located near the West Basin inlet. As the parade moved northeast along Shelter Island and turned east to parallel Harbor Island, spectator vessels located near the West Basin inlet would have been primarily to the left of the parade route. Other than the spectator vessels near the West Basin inlet, vessels were also located along the shore of Harbor Island. **Figure 10** shows conditions near the accident site.

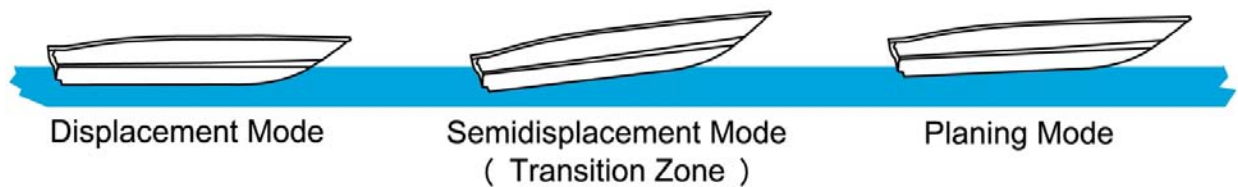
Figure 12. Stages of generic vessel planing and corresponding trim angles.

The SPC-LE is considered a high-speed planing boat. The hull of such a vessel will rise, that is, be on plane, as the vessel attains higher speeds. As a vessel's speed increases, it passes from displacement to semidisplacement (transition) mode, to planing mode. Once a vessel is in planing mode, planing can be maintained with a slight reduction in engine power. Vessels typically reach their highest trim angle⁵¹ in the transition zone (**figure 12**). In general, planing boat operators avoid traveling in the transition zone because of the obstructive effects of the high trim angles on their forward visibility, and because of poor fuel economy. In addition, operating in the transition zone causes large wakes.

Visibility from the helm of the SPC-LE is therefore affected by the hull trim angle, which is itself affected by several factors: the weight and distribution of fuel, persons, and gear on board the vessel; vessel speed; sea conditions; trim position of the outboard engines; and the horsepower and rpm of the outboard engines. As on many planing boats, as the vessel transitions between displacement mode and planing mode, the hull is subject to its largest operating trim angle. A high trim angle reduces forward visibility because the height of the bow above the water line obstructs the operator's forward view of the water. Once the vessel reaches planing speed and the bow begins to trim downward, forward visibility improves.

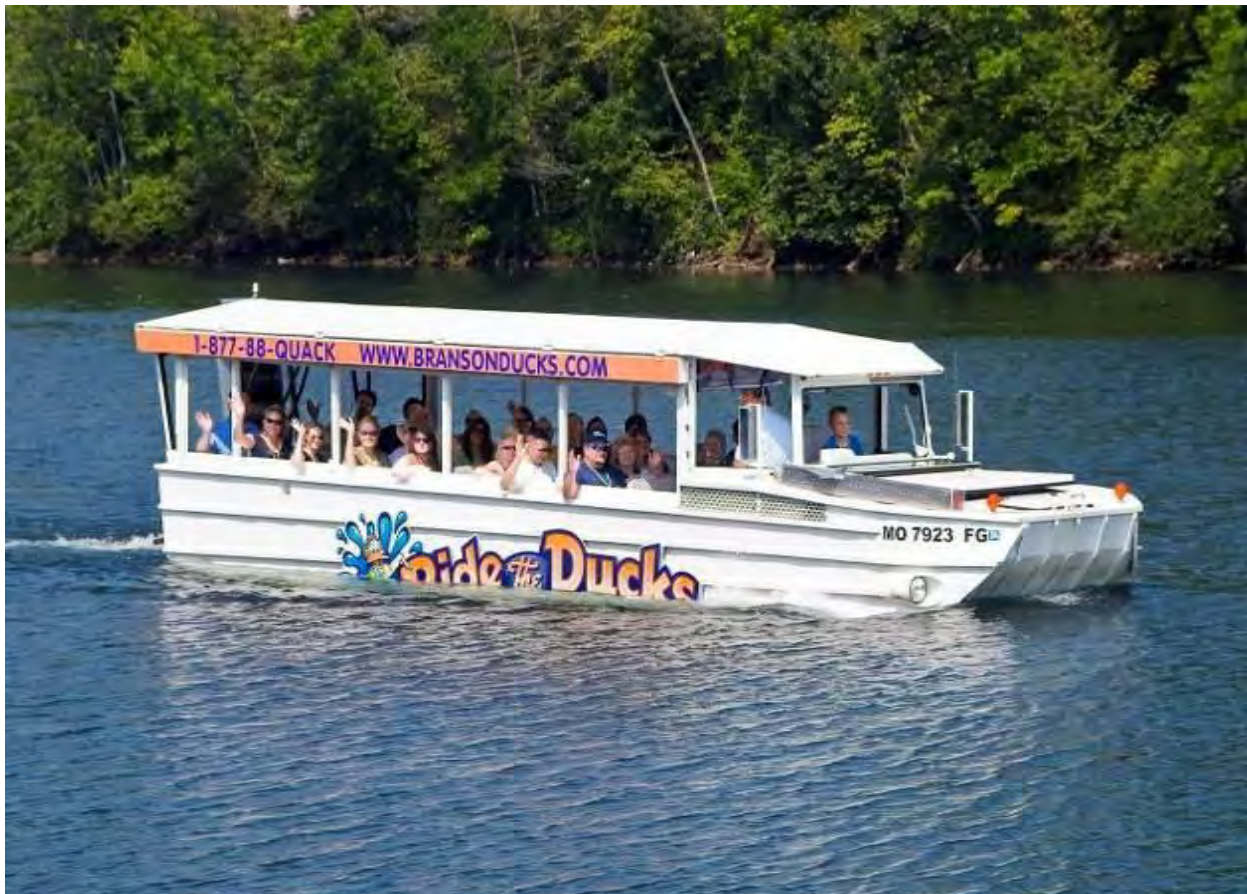
Figure 1. A Ride the Ducks APV similar to the one involved in this accident. (Photo by Ride The Ducks International)

At 1415,¹ on Wednesday, July 7, 2010, the amphibious passenger vehicle (APV) *DUKW*²34, carrying 35 passengers and a crew of two (master and deckhand), entered the Delaware River at a boat ramp just south of the Benjamin Franklin Bridge in Philadelphia, Pennsylvania (figure 1).

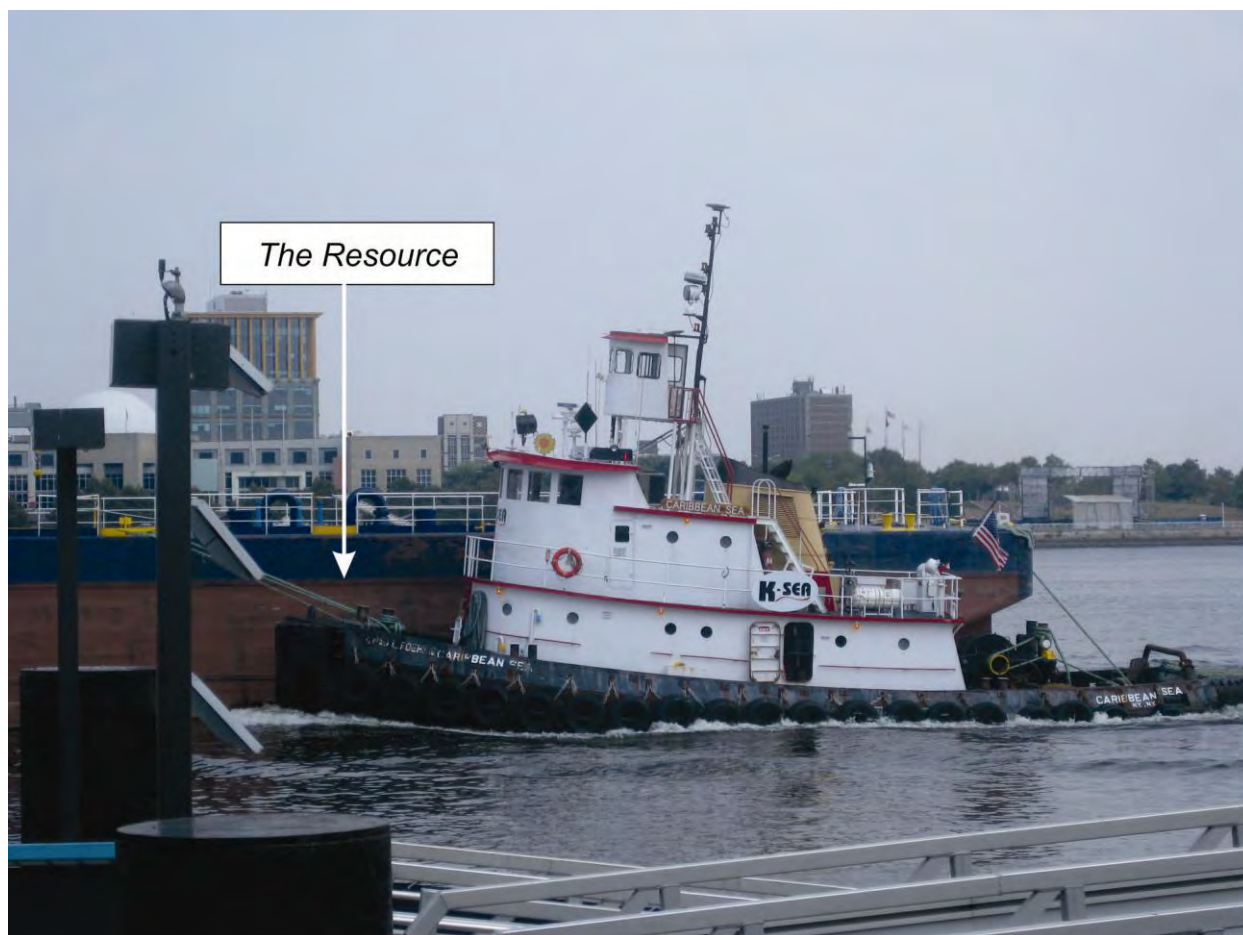
Figure 3. Tugboat *Caribbean Sea* with tank barge *The Resource* in a starboard hip tow as seen about 45 seconds before the accident. (Photo by Megan Scharpf)

At least two of the still photographs (included as figures 3 and 4 in this report) provide fairly clear images of the upper wheelhouse of the *Caribbean Sea* just before and just as the barge struck the APV. Figure 11 shows enlargements from figures 3 and 4 that provide close-up views of the upper wheelhouse just before and after the accident. The enlargement from figure 3 shows the upper wheelhouse in a profile view. The door is open, and the wheelhouse appears to be empty. Anyone at the helm would have been visible through the un-tinted windows. The enlargement from figure 4, taken just after the bow of the barge *The Resource* struck the APV, shows the upper wheelhouse from almost a rear 3/4 view. A portion of the interior of the wheelhouse is visible through the open door. In this image, too, the upper wheelhouse appears to be empty.

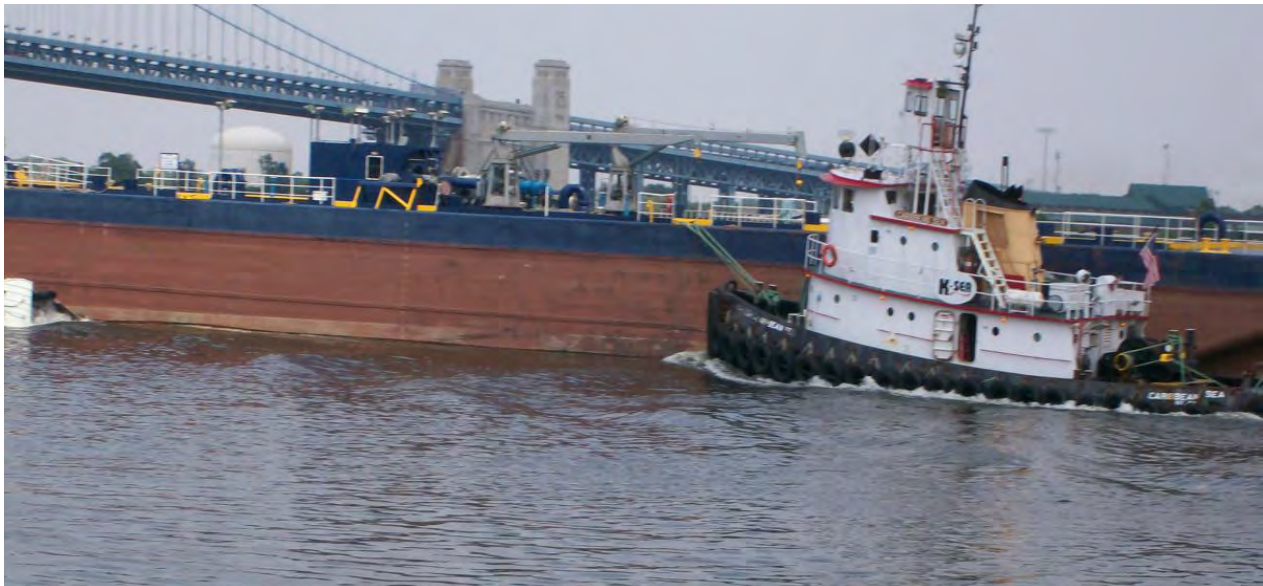
Figure 4. Tugboat *Caribbean Sea* and barge *The Resource* seconds after the bow of the barge made contact with *DUKW 34*, a portion of which is visible at far left. (Photo by Brian E. Stover)

A video security camera on the New Jersey side of the river captured the accident sequence. According to the time correlation study¹¹ on the video, the barge made contact with the stern of *DUKW 34* at 14:37:23. Ten seconds later, at 14:37:33, the APV, having been turned to port, rolled over onto its starboard side and was pushed completely under the water (figure 4). Based on AIS data, in the minutes before the accident, the *Caribbean Sea* was near the center of the river's navigation channel and traveling at about 6 knots.

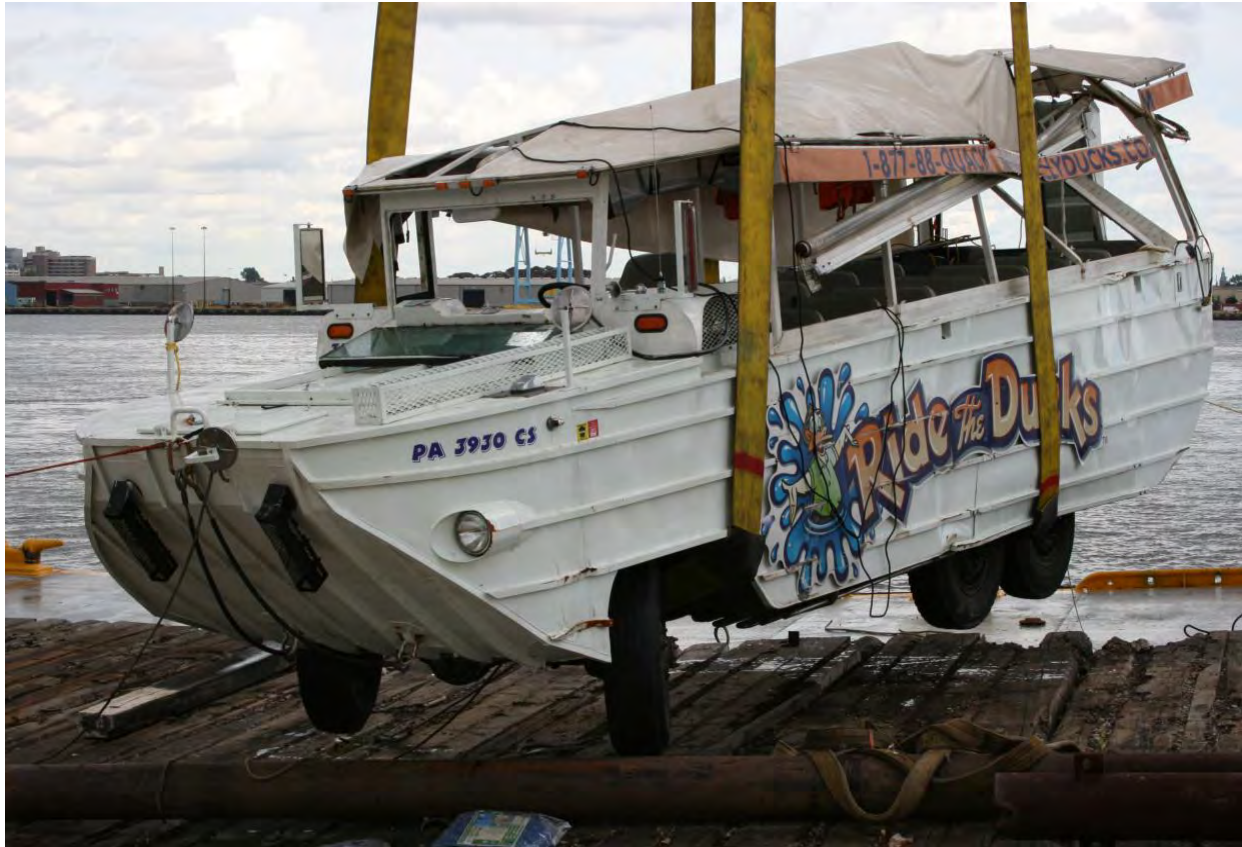
Figure 6. *DUKW 34* after being raised from the river bottom.

DUKW 34 was raised from the river on July 9, 2010. Damage to the APV was principally to the port side of the hull and the aft portion of the port side of the canopy. The hull damage consisted of scrapes and indentations along the hull's external support members and hull shell, and to the "Ride The Ducks" sign attached to the side of the hull. The scrapes to the Ride The Ducks indicated the relative movement between the APV and the barge during their period of contact (figure 6).

At impact, *DUKW 34* rolled to starboard and across the bow of *The Resource* before being pushed underwater at the port side of the barge's bow. It therefore escaped the crushing damage it would have received had it ridden under the barge. As a result, most of the passengers, even though submerged in the vehicle, were able to escape from the almost-intact APV (refer to figure 6).

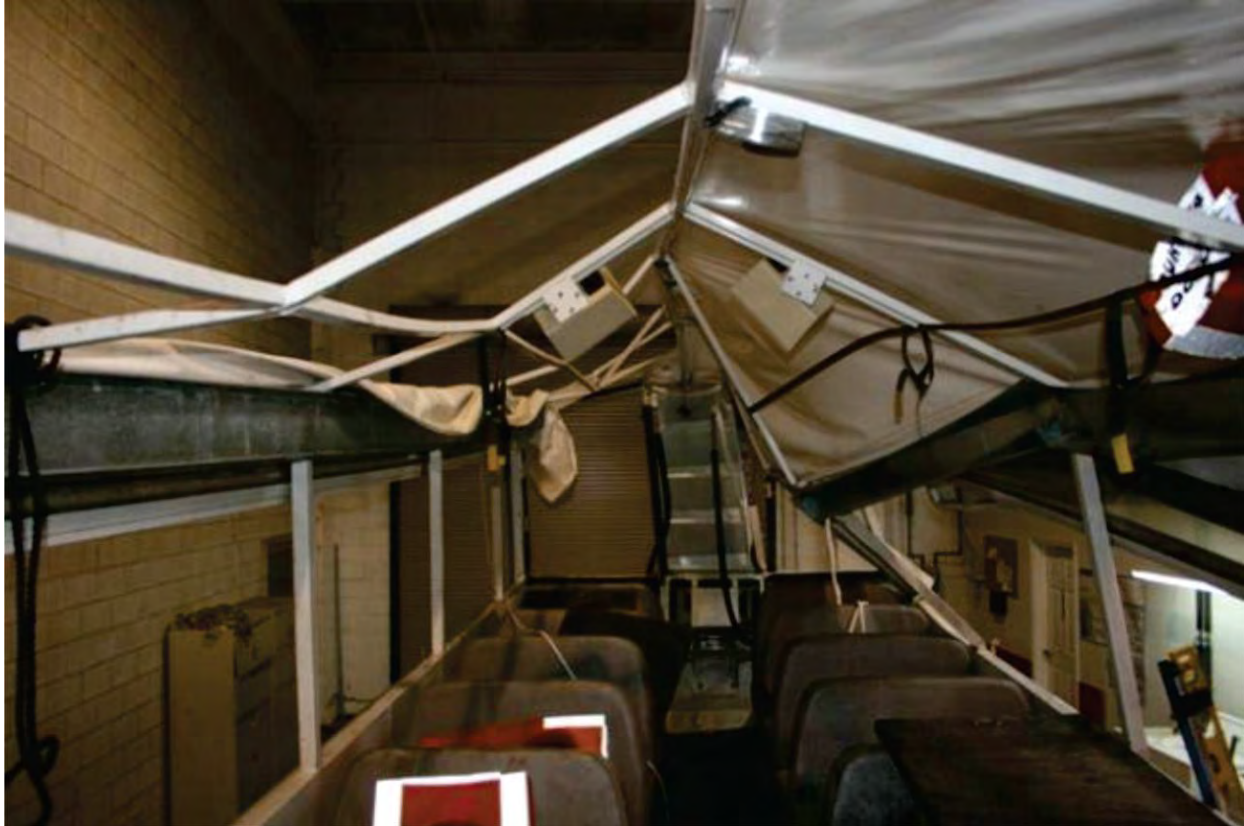
Figure 7. View of *DUKW 34*'s damaged canopy, looking aft.

Damage to the canopy framing system (figure 7) consisted of bending and buckling of the square and rectangular steel tubing and some tearing of the canopy awning, principally at the aft portion. The two aftermost port side vertical frames of the canopy were bent over about 45°, and other support members were similarly damaged. The port-side roller curtain was damaged and detached from its mountings, and the passenger loading ladder indicated distortion and impact damage. The left front wheel was slightly displaced from its axis of rotation, and a subsequent tear-down examination showed that its drive axle was slightly bent.

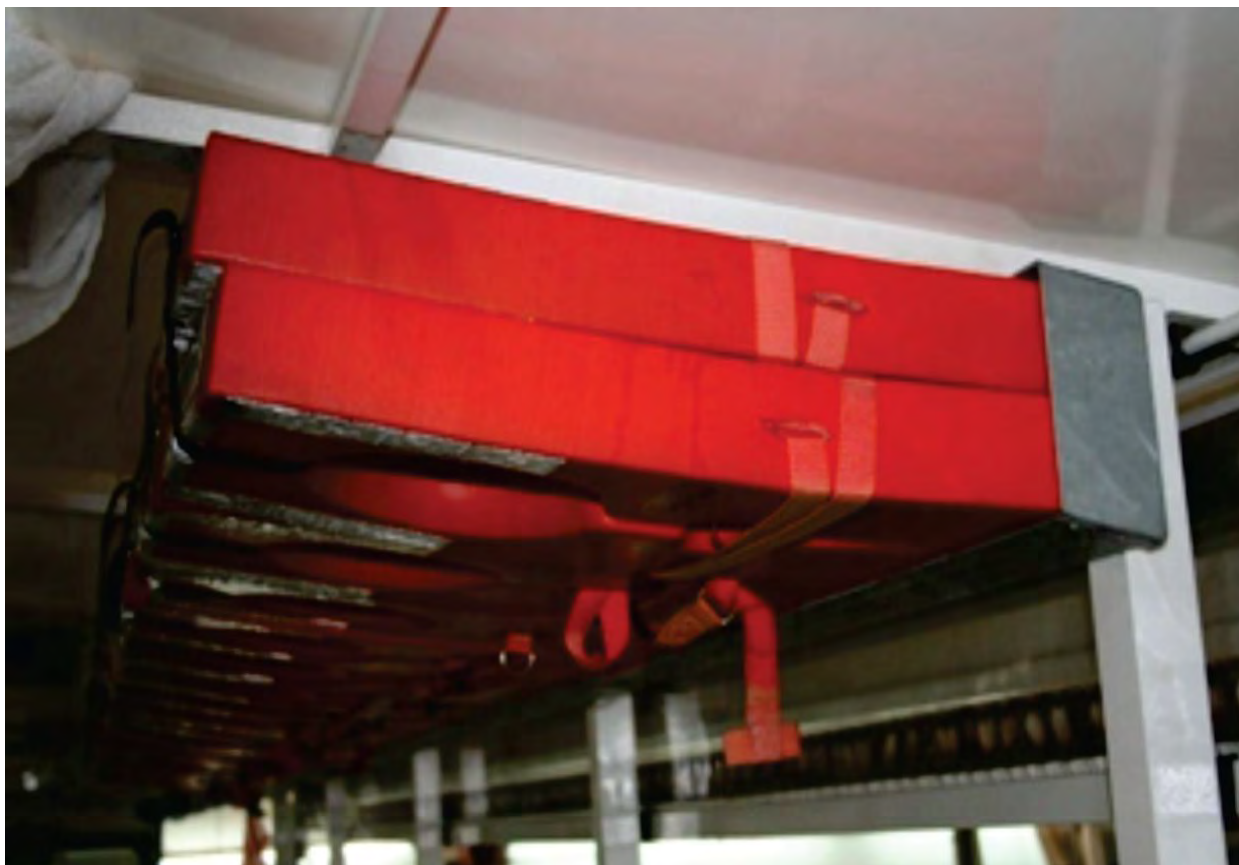
Figure 8. Lifejackets on Ride the Ducks APVs were stowed in stacks of two above each row of passenger seats. Adult jackets were on the starboard side; child jackets were on the port side.

Lifejackets were stowed in the overhead on both sides of the vessel. Adult lifejackets were stowed in stacks of two on the starboard side above all but the last row of seats. Child-size lifejackets were stowed similarly on the port side and were above all but the last 3 rows of seats. The bottom end of each lifejacket was resting in a metal channel just below the canopy on each side (figure 8).

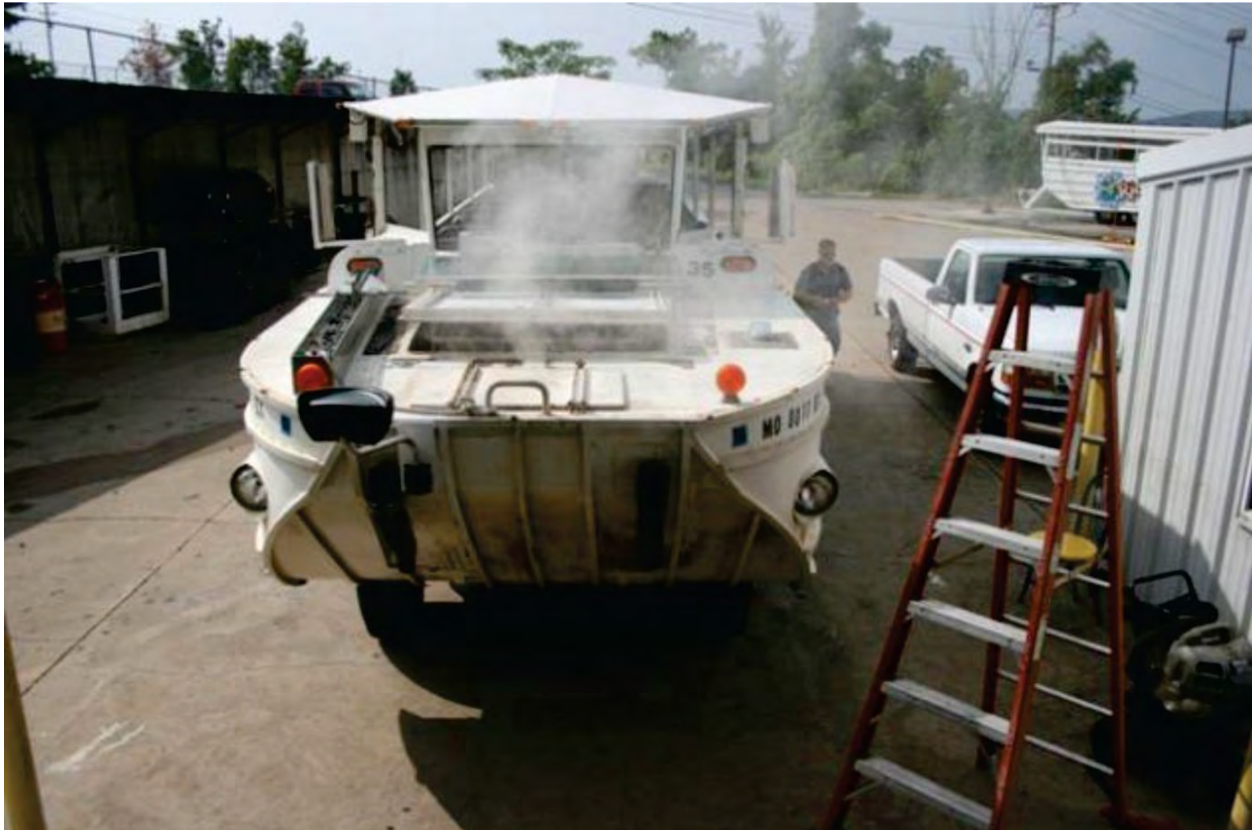
Figure 10. Steam from the engine compartment of a test APV, with cooling water temperature of about 220° F.

The test run consisted of on-road travel only,⁴⁸ and no attempt was made to match the test load to the passenger load on *DUKW 34* at the time of the accident. At the time of the test, the ambient air temperature was about 72° F. After about 10 minutes of on-road travel, the engine coolant temperature increased to about 220° F, at which time steam from the boiling coolant could be seen escaping from the vessel hood and began entering the passenger cabin from the starboard engine compartment vent (figure 10).

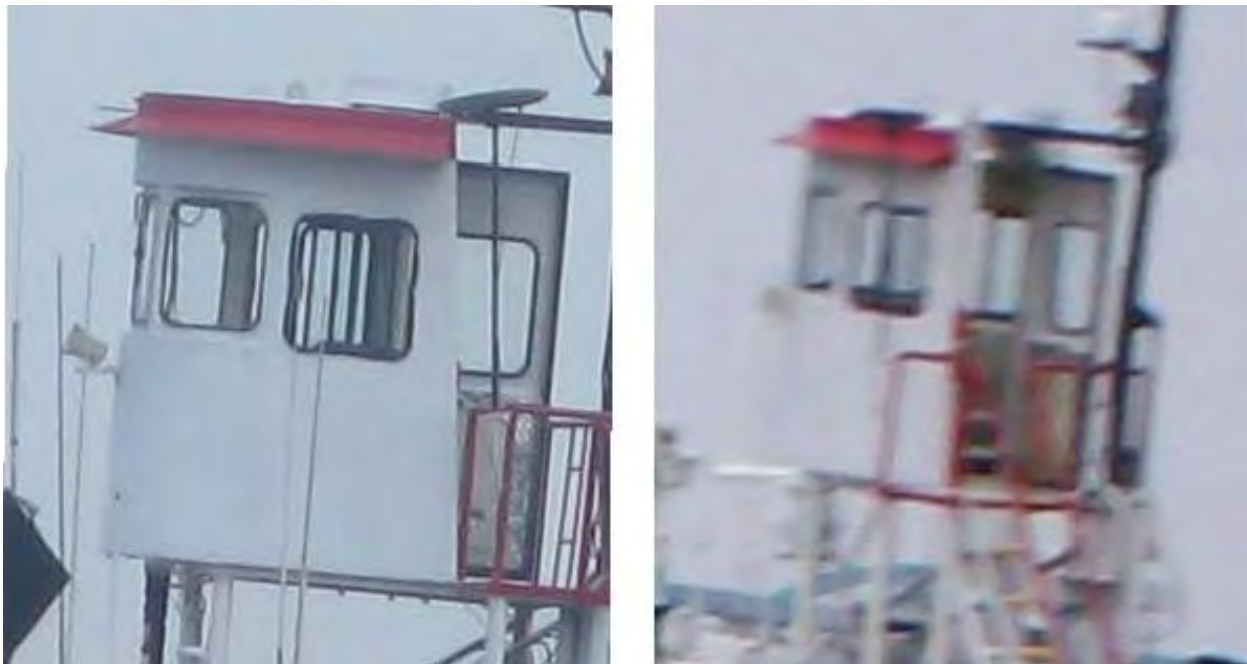
Figure 11. (Left) Enlargement from figure 3, showing the *Caribbean Sea*'s upper wheelhouse about 45 seconds before the collision. (Right) Enlargement from figure 4, showing the *Caribbean Sea*'s upper wheelhouse just as the bow of the barge strikes *DUKW 34*.
